Vehicle Incidents & Lessons Learned Natural Gas Vehicle Technology Forum February 22, 2018

Incident Investigation & Root Cause Analysis

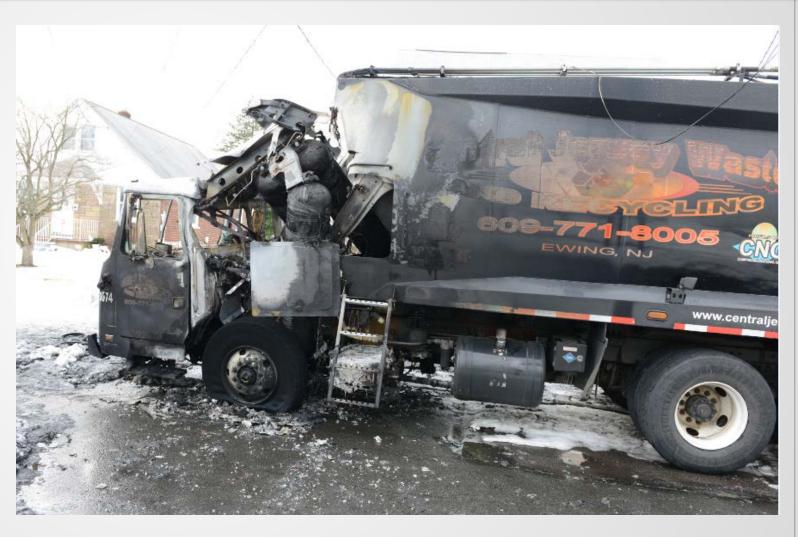
- January 26, 2016
- Hamilton, NJ
- Five cylinder design 'L' layout
- Fire initiated near battery box
- Four of the five cylinder PRDs activated
- One cylinder ruptured, causing extensive damage to a nearby home

Next Steps:

- Destructive testing of PRDs
 - Measure flow rate (capacity) of five subject T-PRDs per clause 7.13 of ANSI PRD 1-2013 nitrogen gas at 10 bar ± 1 bar. Compare with design qualification values.
 - Disassemble samples 1, 4 and 5 subject T-PRDs
 - Visual examination of internal condition of samples 1, 4, and 5 subject T-PRDs, including sampling of eutectic alloy, determine mass of remaining eutectic material compared to nominal value.
 - Perform dimensional checks of internal parts per design drawings.
 - Perform metallographic and compositional analysis of eutectic material of samples 1, 4 and 5 subject T-PRDs.

- Feed results back to industry
 - NGVAmerica Technology & Development Committee
 - CSA/ANSI PRD1 TSC
 - CSA/ANSI NGV3.1 TSC
 - CSA/ANSI NGV6.1 TSC
 - NFPA 52

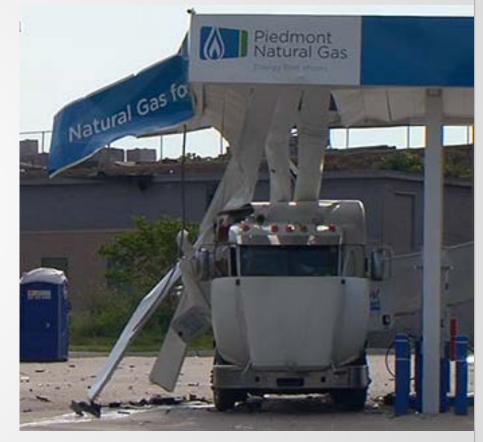
Nashville Filling Station / Class 8 CNG Truck

- May 31, 2016
- Nashville, TN Filling Station
- Two side-mount saddle tanks
- Driver hit something "substantial" with right front steer tire about 15 miles prior to stopping at the filling station
- Between 500 and 700 psi of CNG on vehicle at time of impact
- As driver was filling, passenger cylinder let go, causing damage to vehicle, station and driver who was thrown off of the right front steer tire

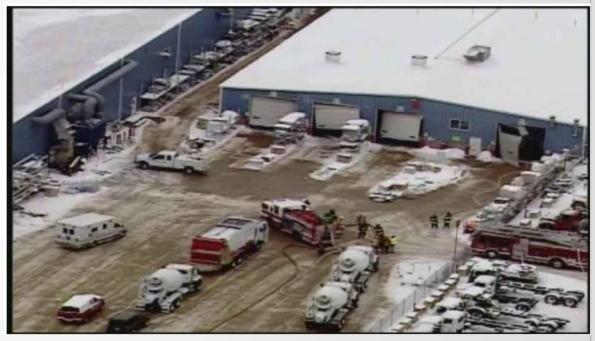
Paint Booth Facility – Dodge Center, MN

- January 11, 2017
- Paint Booth facility
- Refuse truck with CNG tanks on top of hopper
- Leak in a high pressure hose in a heated paint booth
- CNG fuel system was full at the time of leak
- The leak caused an explosion in the facility, resulting in damage to the paint booth, vehicle and six employees at the facility

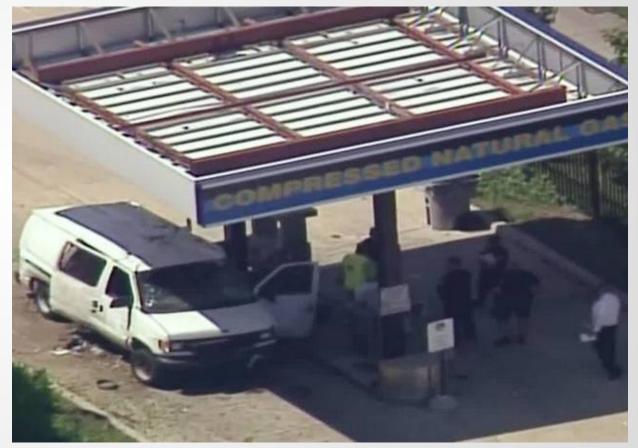
Ford Econoline Midship Tank – Milwaukee, WI

- July 18, 2017
- 1998 Ford Econoline filling at a Milwaukee DPW station
- 3,000 psi fuel system at 3,600 psi station
- The underbody midship cylinder ruptured (the two rear-of-axle cylinders were later detonated by the bomb squad), causing severe damage to the driver's legs.
- The 3600 psi fill connector was still attached to the van after the incident.

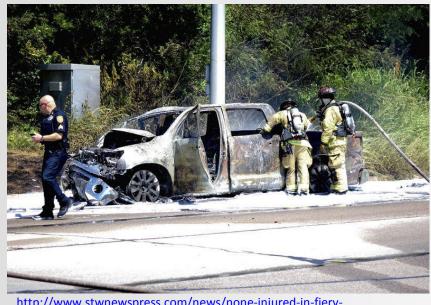
- 2012 Toyota Tundra CNG powered
- Tundra hit a streetsweeper
- June 16, 2017
- Stillwater, OK

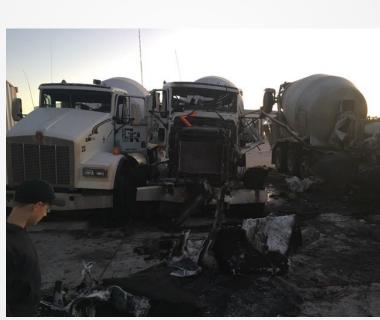
- Dual fuel cement truck
- Overpressurized via time fill
- October 20, 2017
- Columbus, NE
 Colum

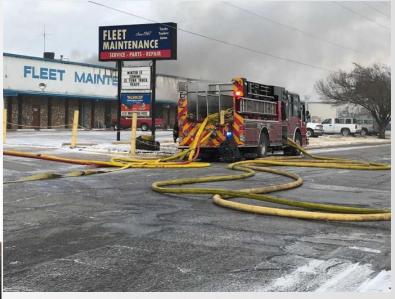
- Fleet Maintenance Shop
- CNG leak, fire at heaters
- January 15, 2018
- Wichita, KS
