# Alt Fuel Vehicle Incidents—Fact and Fiction

**NGV Technology Forum**  
**San Francisco, CA-2015 10 20**

**National Renewable Energy Laboratory**

**Marathon Technical Services**

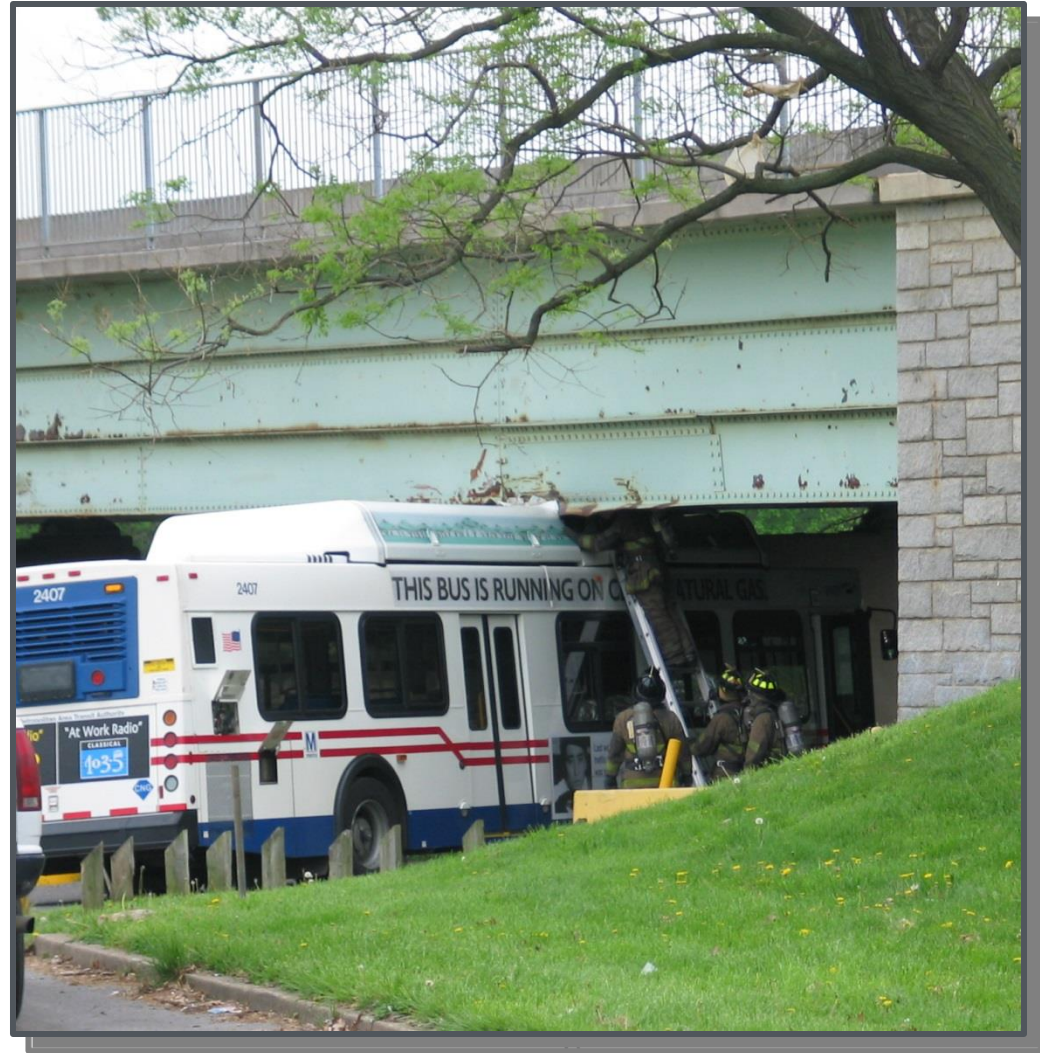
- Bus driver used an unapproved route for football stadium shuttle.
- Overpass was marked but driver drove the 11'-4" bus into the overpass.

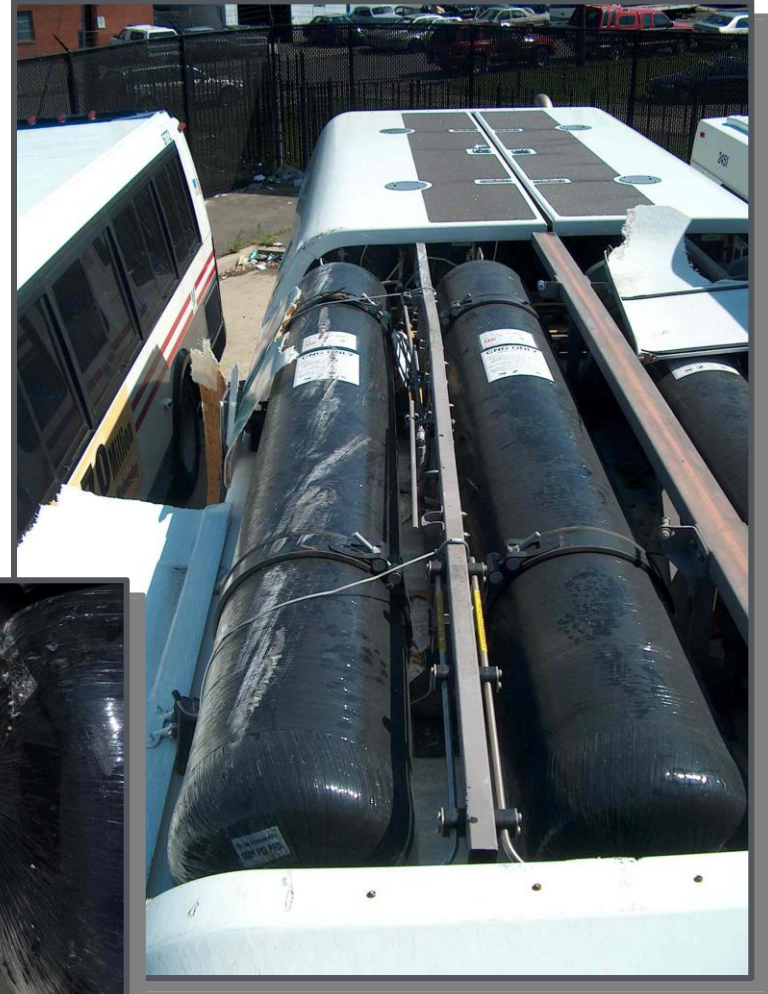
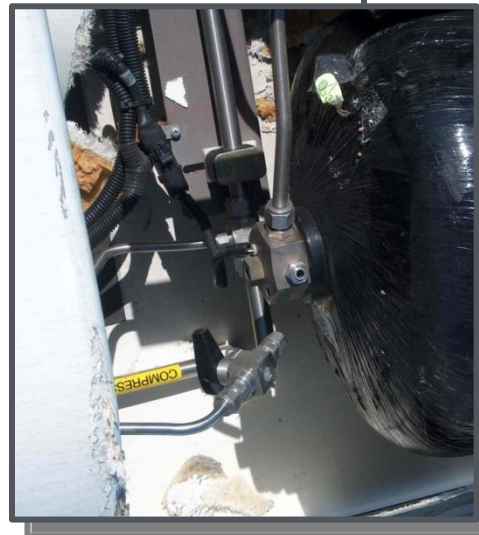
- One cylinder was scraped and gouged.
- One line on the cylinder was severed—internal solenoid valve stopped flow.

- No cylinders vented down.
- No ignition/fire or explosion occurred.
- Gas detection system sensed gas (line leak) and shut down the bus-isolating the gas cylinders.
- No personnel injury or third party property damage occurred.
- One cylinder was replaced. The bus roof was repaired and the bus was successfully placed back in service.

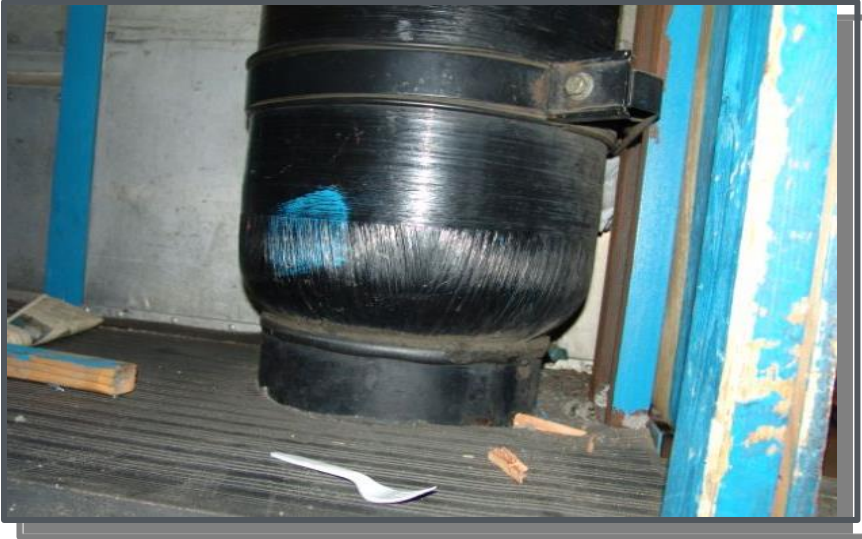
Cylinder improperly mounted on steel ring

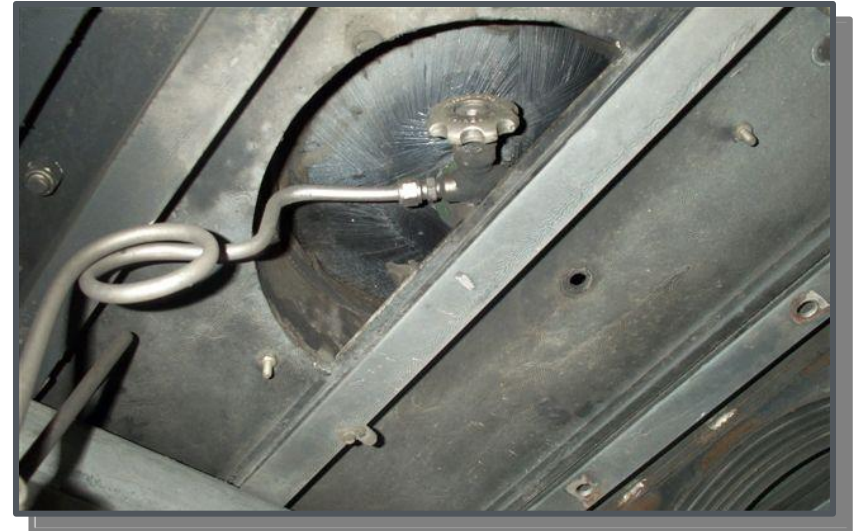
No shielding of exposed cylinder under vehicle – this dome failed

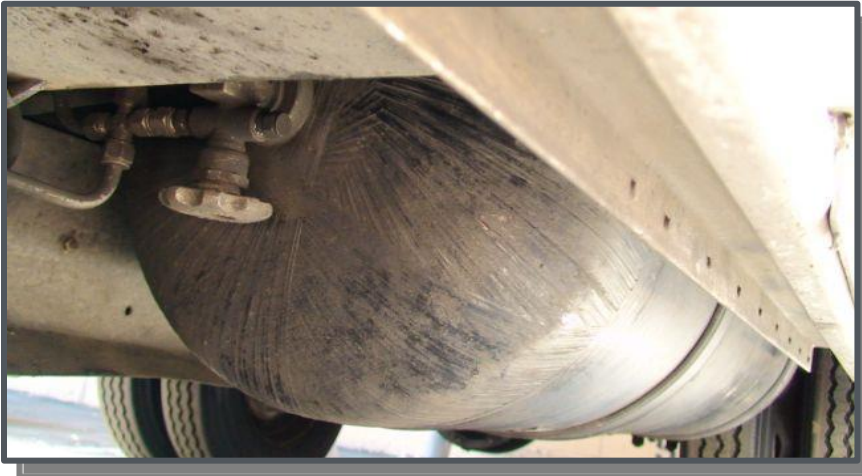
- Poorly installed cylinder was damaged by road debris or from the mounting ring.
- Damaged cylinder failed during fueling cycle.
- Shrapnel from the failed cylinder caused a second cylinder to fail.
- One serious personnel injury – no deaths.
- Vehicle destroyed.

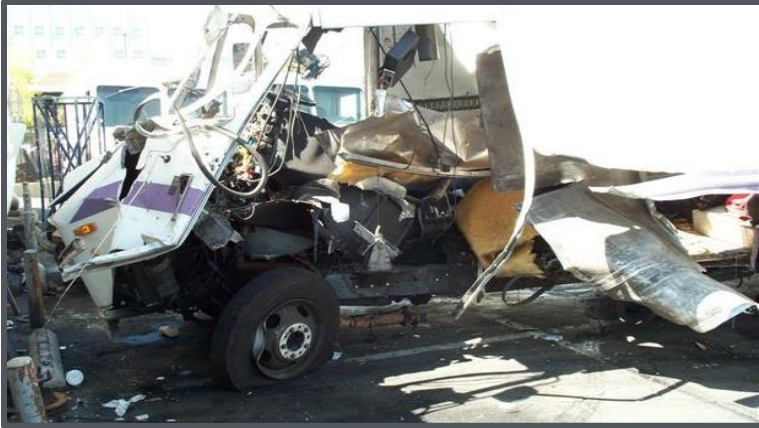
Vertical cylinder landed 200 ft away

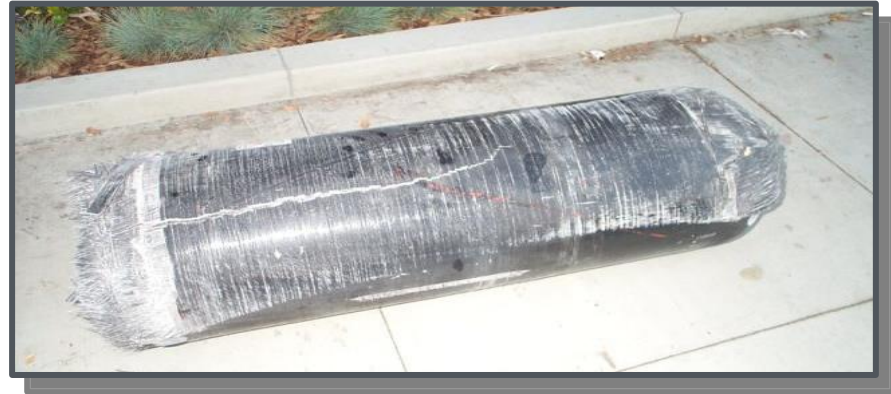
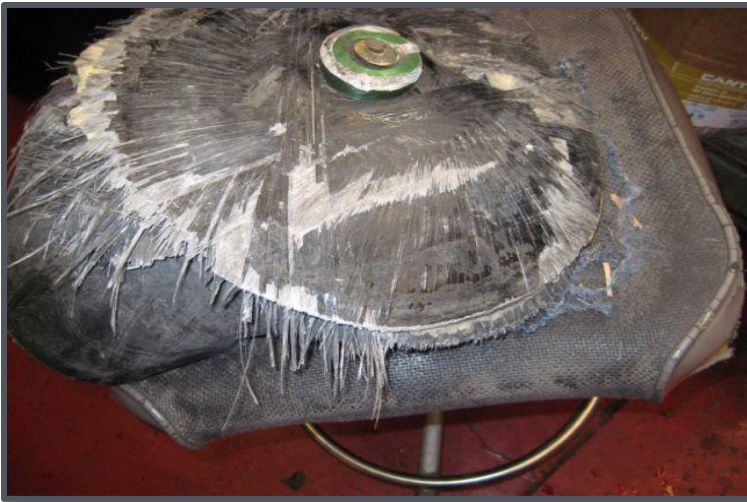
Dome of vertical cylinder found in truck

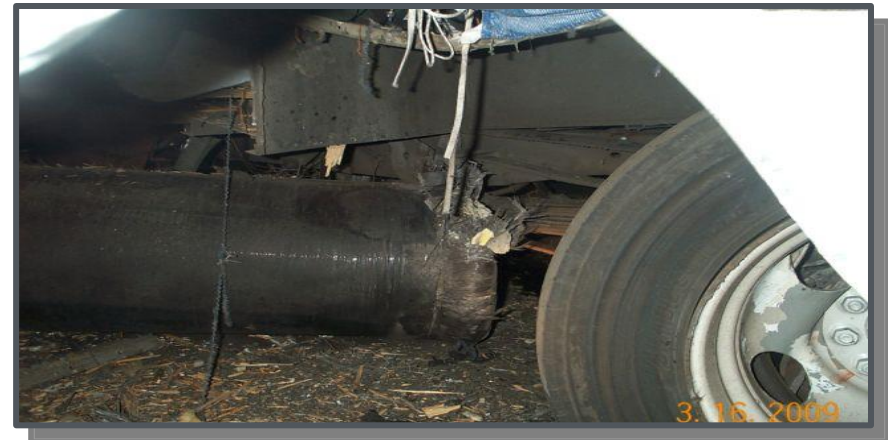
Dome of under mount cylinder failed

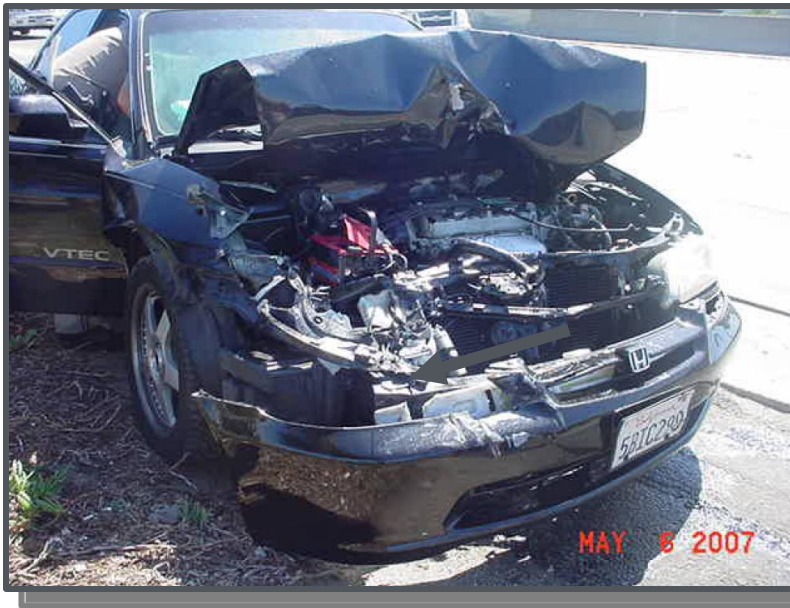
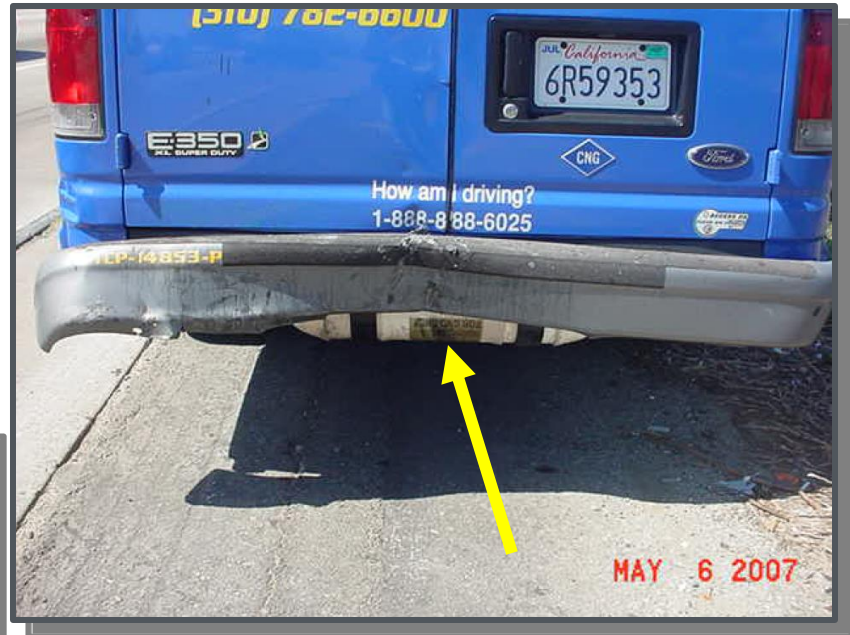
- Van was rear-ended on May 6, 2007 by Honda Civic which “submarined” under the rear of the van.

- Cylinder a Comdyne Type 3 (fully over-wrapped aluminum lined).
- Cylinder added aftermarket. Installation not code compliant—vulnerable location on vehicle and not shielded.
- Unclear what inspection after accident.
- Van body damage was repaired.
- It is believed that the cylinder was not inspected prior to final fueling incident.

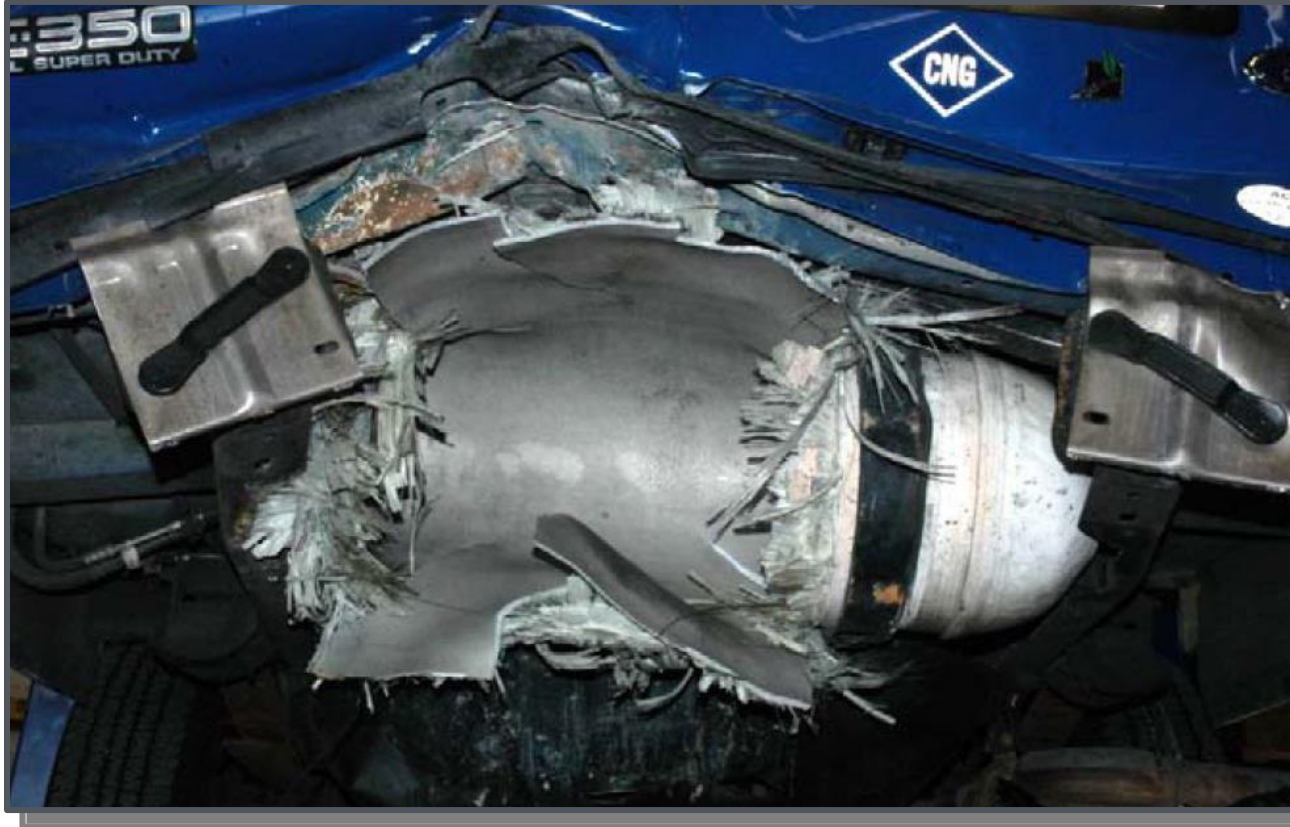
- Comdyne Type 3 Cylinder ruptured during fueling, killing the driver who was fueling the vehicle.

- Cylinder was within rated life and rated at 3600 psig but failed at 2650 psig.
- It is believed that the cylinder failure was due to Stress Corrosion Cracking related to the exposure of the cylinder to battery acid during the traffic accident. At least 3 incidents with Comdyne cylinders attributed to battery acid.
- The vehicle driver was killed during the fueling incident.

- Ensure cylinders are within rated life and rated  $\geq$  operating pressure of the vehicle.
- Train staff for regular cylinder inspections, or hire a qualified 3<sup>rd</sup> party inspector.
- Inspect cylinders according to required intervals (typically 3 years or 36,000 miles).
- Maintain cylinder inspection records.
- Vehicle inspection after incident—not all damage is apparent from inspection. Safely remove and dispose of cylinders if there is uncertainty of the integrity of the cylinder.

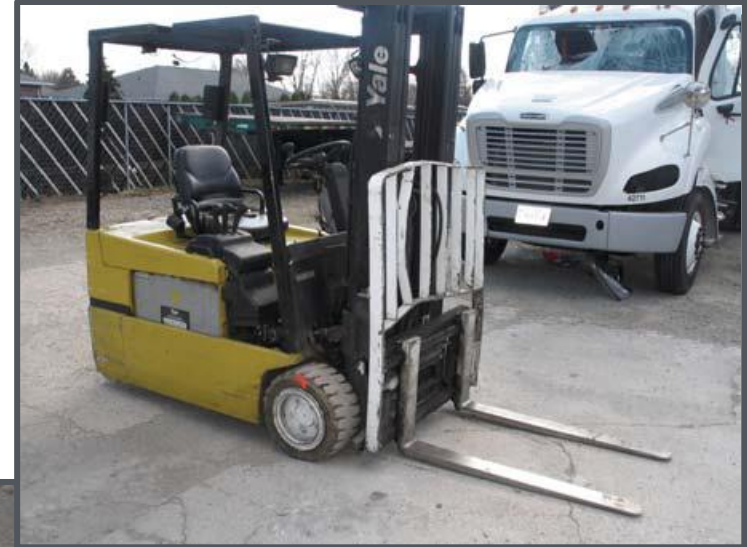
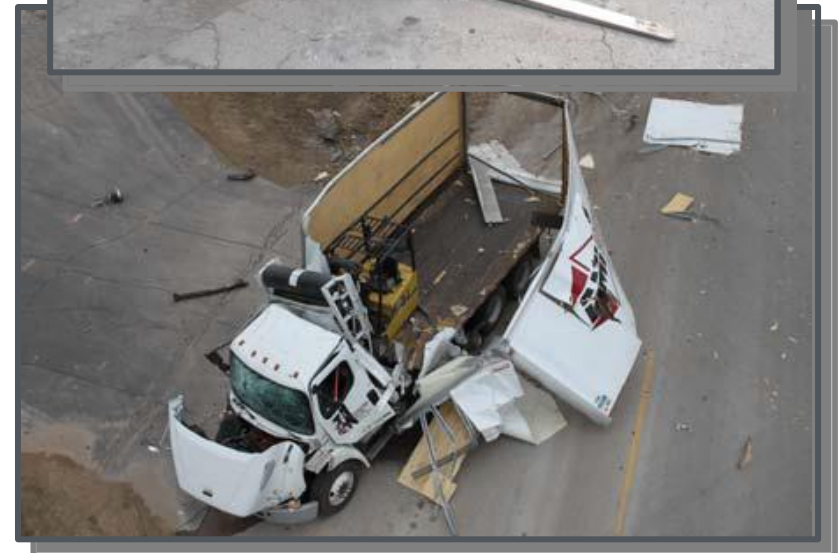
- Yale Type E forklift loaded unsecured in cargo box Freightliner M2 112
- Driver and passenger both seatbelted.
- Driver was braking to initiate a right turn into a driveway

- Forklift shifted forward as a result of the deceleration
- One of vehicle's 5 CNG cylinders punctured by left forklift fork
- Cylinder failed catastrophically.

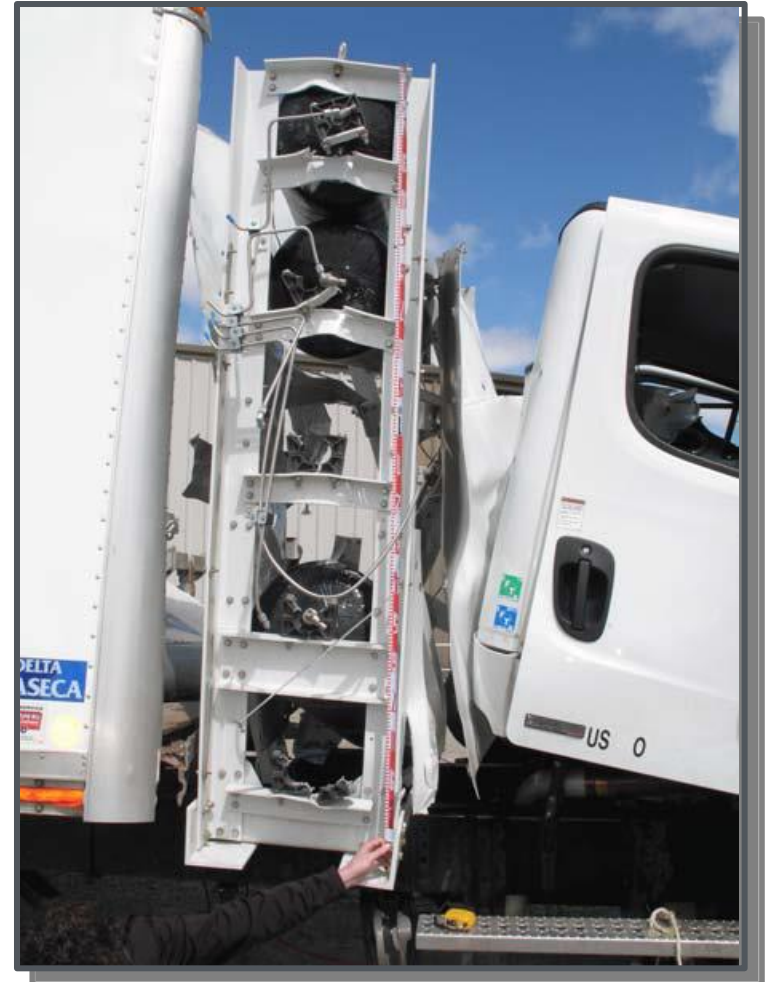
- The driver died at the scene.
- Passenger sustained incapacitating injuries and was hospitalized for one day.
- No fire or secondary damage.
- Vehicle was fueled the previous evening.

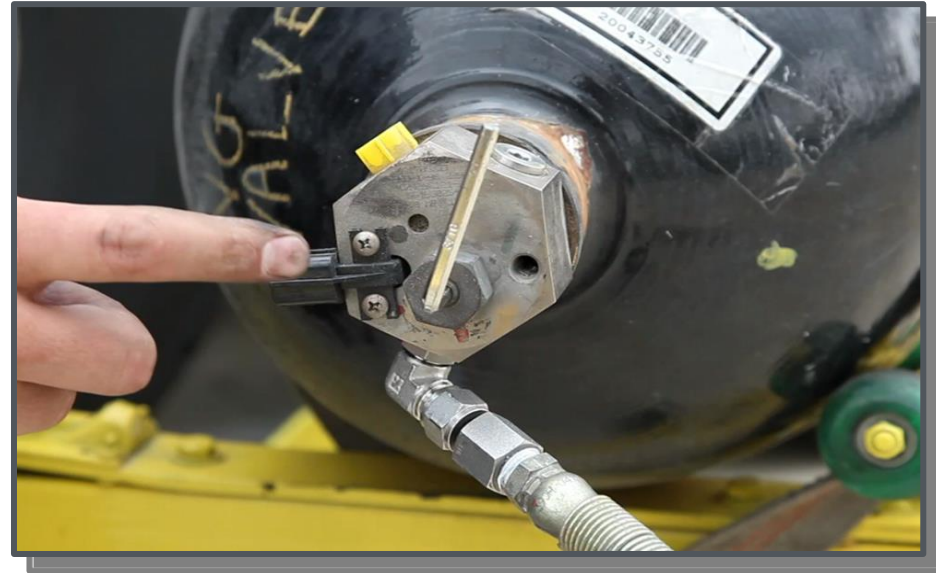
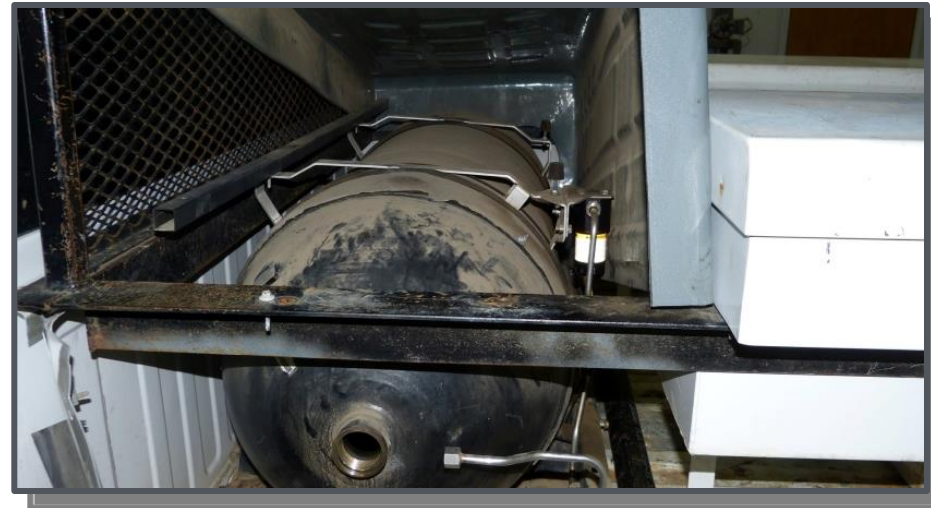
- It is believed that internal solenoid valve failed closed.
- Cylinder valve was removed without using standard procedures prescribed by manufacturer.

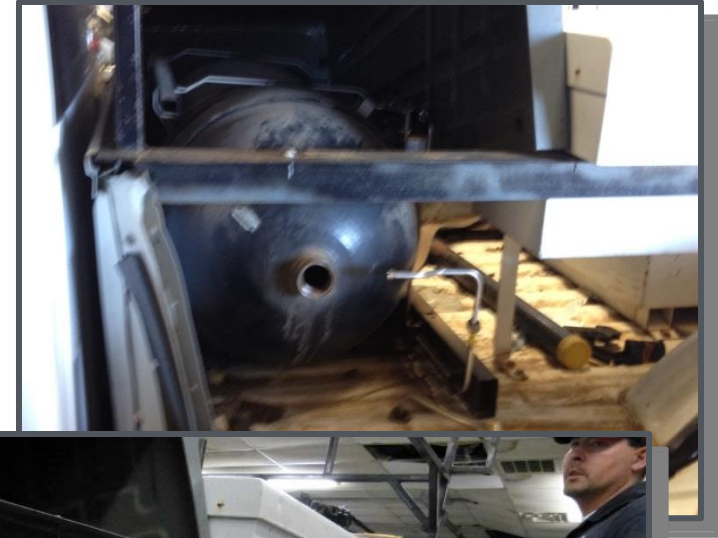
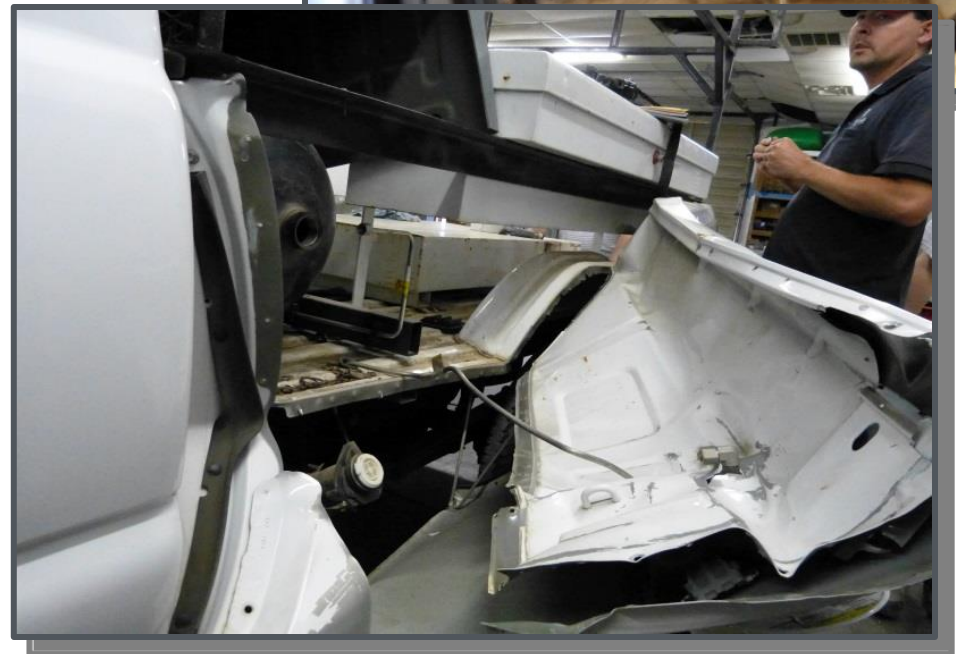
- Manual override tool that allows for safe tank venting was not used to determine if cylinder was pressurized.
- Incomplete venting lead to valve being launched at the technician, who was fatally injured
